Partnerships in Watershed Restoration

FISH PASSAGE AND WATERSHED ENHANCEMENT FOR OREGON

ROGUE RIVER, OREGON

FOOTS CREEK FISH PASSAGE IMPROVEMENT

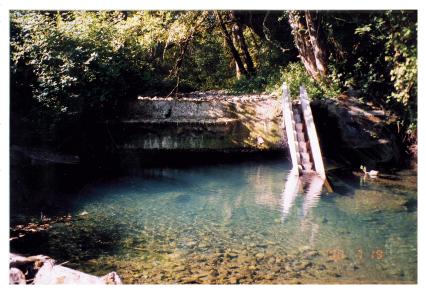
Photo 1. The Foots Creek Dam, shown in July 2000 prior to removal. A Deneil-type fish ladder was installed by ODFW. It failed to meet current standards and the force of higher flows over the dam increased erosion in the stream bed and created excess turbidity.

Foots Creek is a productive coho salmon and steelhead stream. It all but dries up in the summer months, but flows in the winter months can reach several hundred cubic feet per second. A Deneil-type fish ladder was installed by Oregon Department of Fish and Wildlife (ODFW) in 1998 and was not as effective as hoped. The problem to be solved was how to make the diversion "fish friendly," a move which would improve the health of the anadromous fish stocks, which in turn would benefit all members of RBCC.

Foots Creek Dam is a concrete dam about 5 feet high and 40 feet wide. In addition to being a barrier to fish passage, it causes unnecessary erosion and turbidity from the high energy plunge at the dam. The dam was installed about 50 years ago to provide irrigation and recreation water for the landowners who use the property. Finding an alternative to this diversion was a high priority to RBCC and ODFW. The present landowner uses the water diverted from the dam to fill, by gravity pipeline, a pond about 280 feet away. The pond is used for recreation, fire suppression, and generally improves the value of the property. Currently, the diversion right is for 9 gallons per minute (about 0.02 cubic feet per second), a decrease from the time of construction.

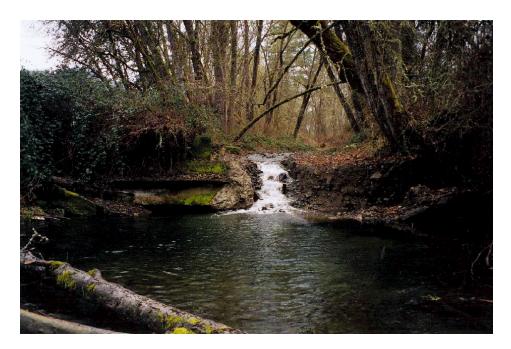
Photo 2. Six months after removal of the Foots Creek Dam, flows are healthy and barriers to fish passage are greatly reduced.

of initial dam construction, the material apparently preferred for concrete reinforcement was narrow-gauge rail once used by the mining industry. This high-quality steel caused severe problems for the pneumatic drills and masonry bits. Many holes were drilled to avoid contact with the rails but the original engineers and construction workers were relentless in their placement of reinforcement. Eventually the left half of the dam was removed (photo 2).

With the removal of the dam, fish passage is now facilitated on Foots Creek. There is now a 6-mile-long reach of Foots Creek that is more easily negotiated by migrating salmonids. The sediments behind the dam

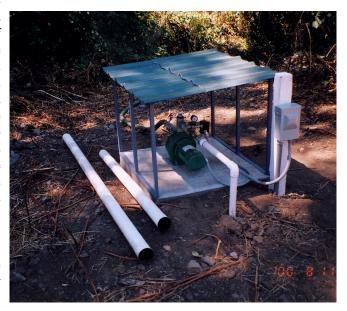
Photo 3. The newly-installed 1-horsepower pump can convey water at the rate of 9 gpm through a 1¼-inch pipeline the 100-yard distance from an infiltration gallery in Foots Creek to the pond.

possible. This was accomplished by the use of a considerable amount of manual labor to avoid the use of heavy equipment. A local irrigation contractor installed the pump, its intake, and pipelines. The PVC pipe was buried from the pump shelter to the pond. The electrical service for the pump was provided by the existing service at the property.

were allowed to remain in place until rising flows from the fall rains disperse the sediments naturally. The pump (photo 3) will require yearly attention and maintenance, and annual operation is estimated to be about \$50. ODFW will monitor use of newly accessible habitat by counting steelhead redds above and below the damsite each year.
